Re: Notice of Civil Penalty Assessment and Order
Case No. WQ/I-ER-2021-186

3 IN THE MATTER OF:)
4 BOISE CASCADE) NOTICE OF CIVIL PENALTY
WOOD PRODUCTS, LLC,) ASSESSMENT AND ORDER
5 a Delaware limited liability company,)
Respondent.) CASE NO. WQ/I-ER-2021-186
6

Memorandum

Subject: Groundwater: *Log Yard Dye Tracer Study Results - Boise Cascade Elgin Complex, Elgin, Oregon*, dated November 16, 2022; *Elgin Complex, 2022 Annual Report, WPCF 103020*, dated February 2023; Groundwater Quality Review – Boise Cascade Log Yard, Elgin, Oregon, dated July 7, 2023.

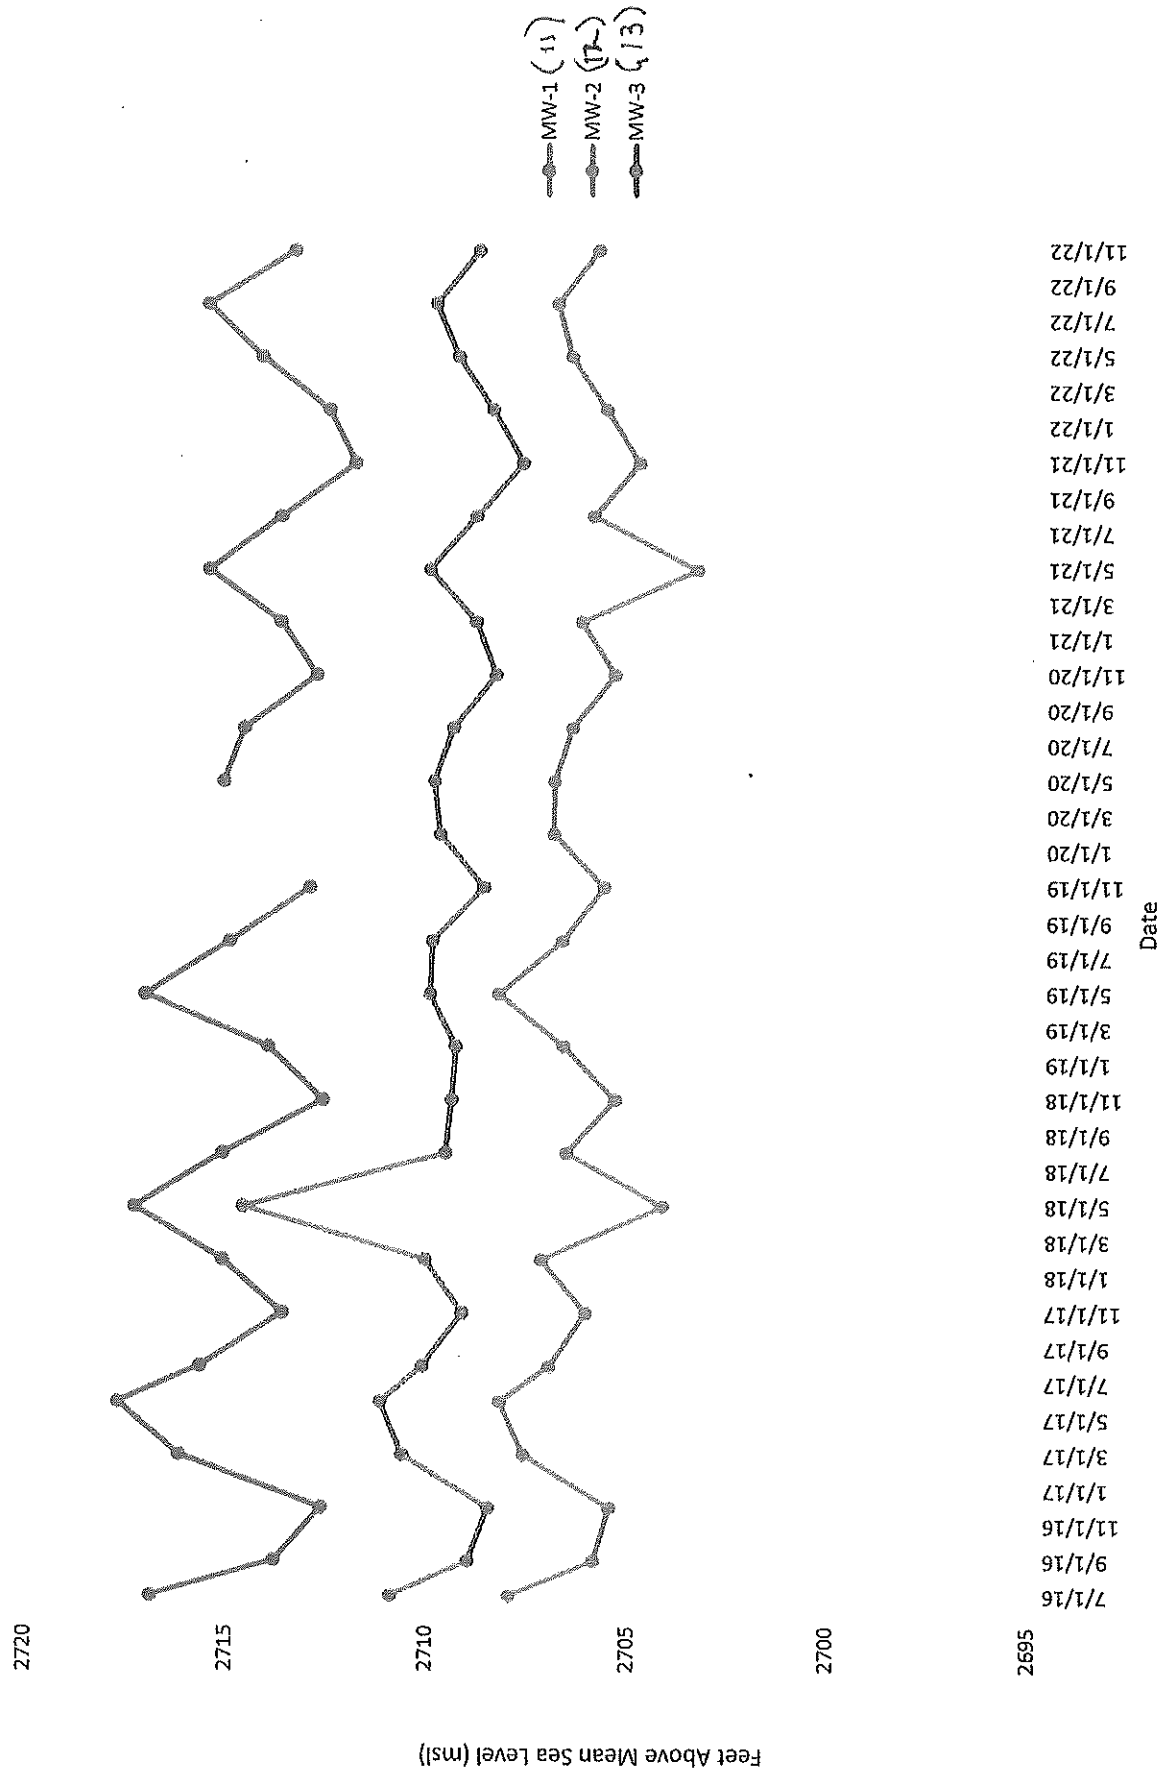
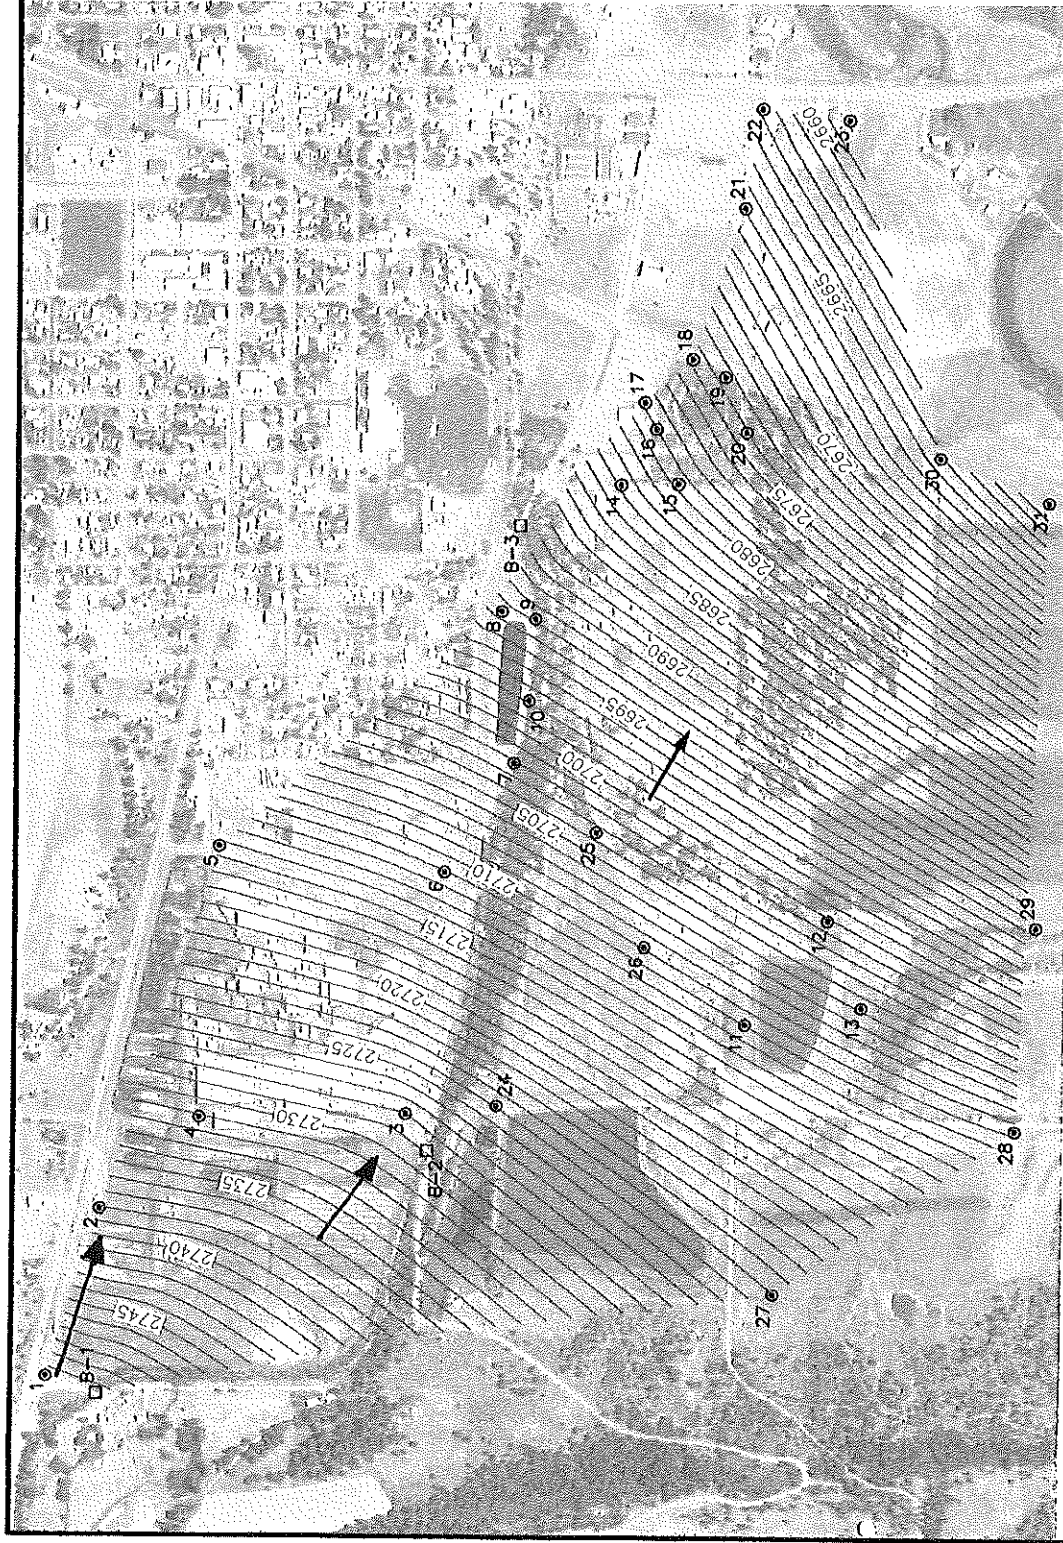
Water level contour maps for the site are inadequate. The contour maps have significant numbers of data points that are omitted from the water level contour maps, with no valid explanation given. Therefore, it is not possible to evaluate upgradient to downgradient comparisons at the site. There are many examples where the groundwater elevations were omitted from the contour maps and the contour maps completely contradict the elevation charts. For example, the Elevation Chart 1 from the PWP2 shows a relatively consistent relationship with MW-1, MW-2 and MW-3. In this example the chart shows MW-1 has the highest elevation and MW-3 the lowest elevation (Chart attached). However, all the quarterly contour maps for 2022 (Attached) show MW-3 higher than MW-2. There are many other examples where the elevation charts are contradictory to the water level contours. This provides convincing evidence that the water level contour maps do not accurately reflect groundwater flow at the site.

Represented groundwater contours across the entire site generally do an unsatisfactory job of representing flow conditions at the site. The flow cannot be accurately represented without incorporation of significant elevation control points including the creek elevations. Based on some of the omitted elevations it appears that the groundwater contours should be showing the creek as a gaining stream at the location of B-2 and B-3. It is less clear in the vicinity of B-1. The contour maps generally ignore the creek elevations and cut straight across the creek, indicating there is no connection with the creek. Additionally, many other elevations are omitted from the contour maps. Many other groundwater elevations are frequently omitted with no reason given for the "questionable" data. The facility must provide adequate justification for elimination of any of the elevations from the contour maps.

The facility must provide a detailed evaluation of all wells at the site and construct accurate groundwater contour maps. Once accurate groundwater contour maps are produced, and valid upgradient to downgradient comparisons can be made, the facility must conduct a Water Quality Analysis Report (WQAR). As part of the WQAR the facility must thoroughly evaluate the groundwater system at the site, determine appropriate contaminants of concern, evaluate upgradient to downgradient concentrations at the site, and propose appropriate concentration limits for the contaminants of concern for each appropriate groundwater monitoring facility (i.e., the log yard, SWTD, etc.).
